STATE OF COLORADO

DIVISION OF MINERALS AND GEOLOGY
Department of Natural Resources1313 Sherman St., Room 215
Denver, Colorado 80203
Phone: (303) 866-3567
FAX: (303) 832-8106

To: ANIMAS PROJECT MINE SITE TEAM**From:** Bruce Stover, *Bruce***Date:** February 5, 1996**DRAFT****Re: DRAFT GEOLOGIC SITE REPORTS**

LONGFELLOW-KOEHLER**Location**

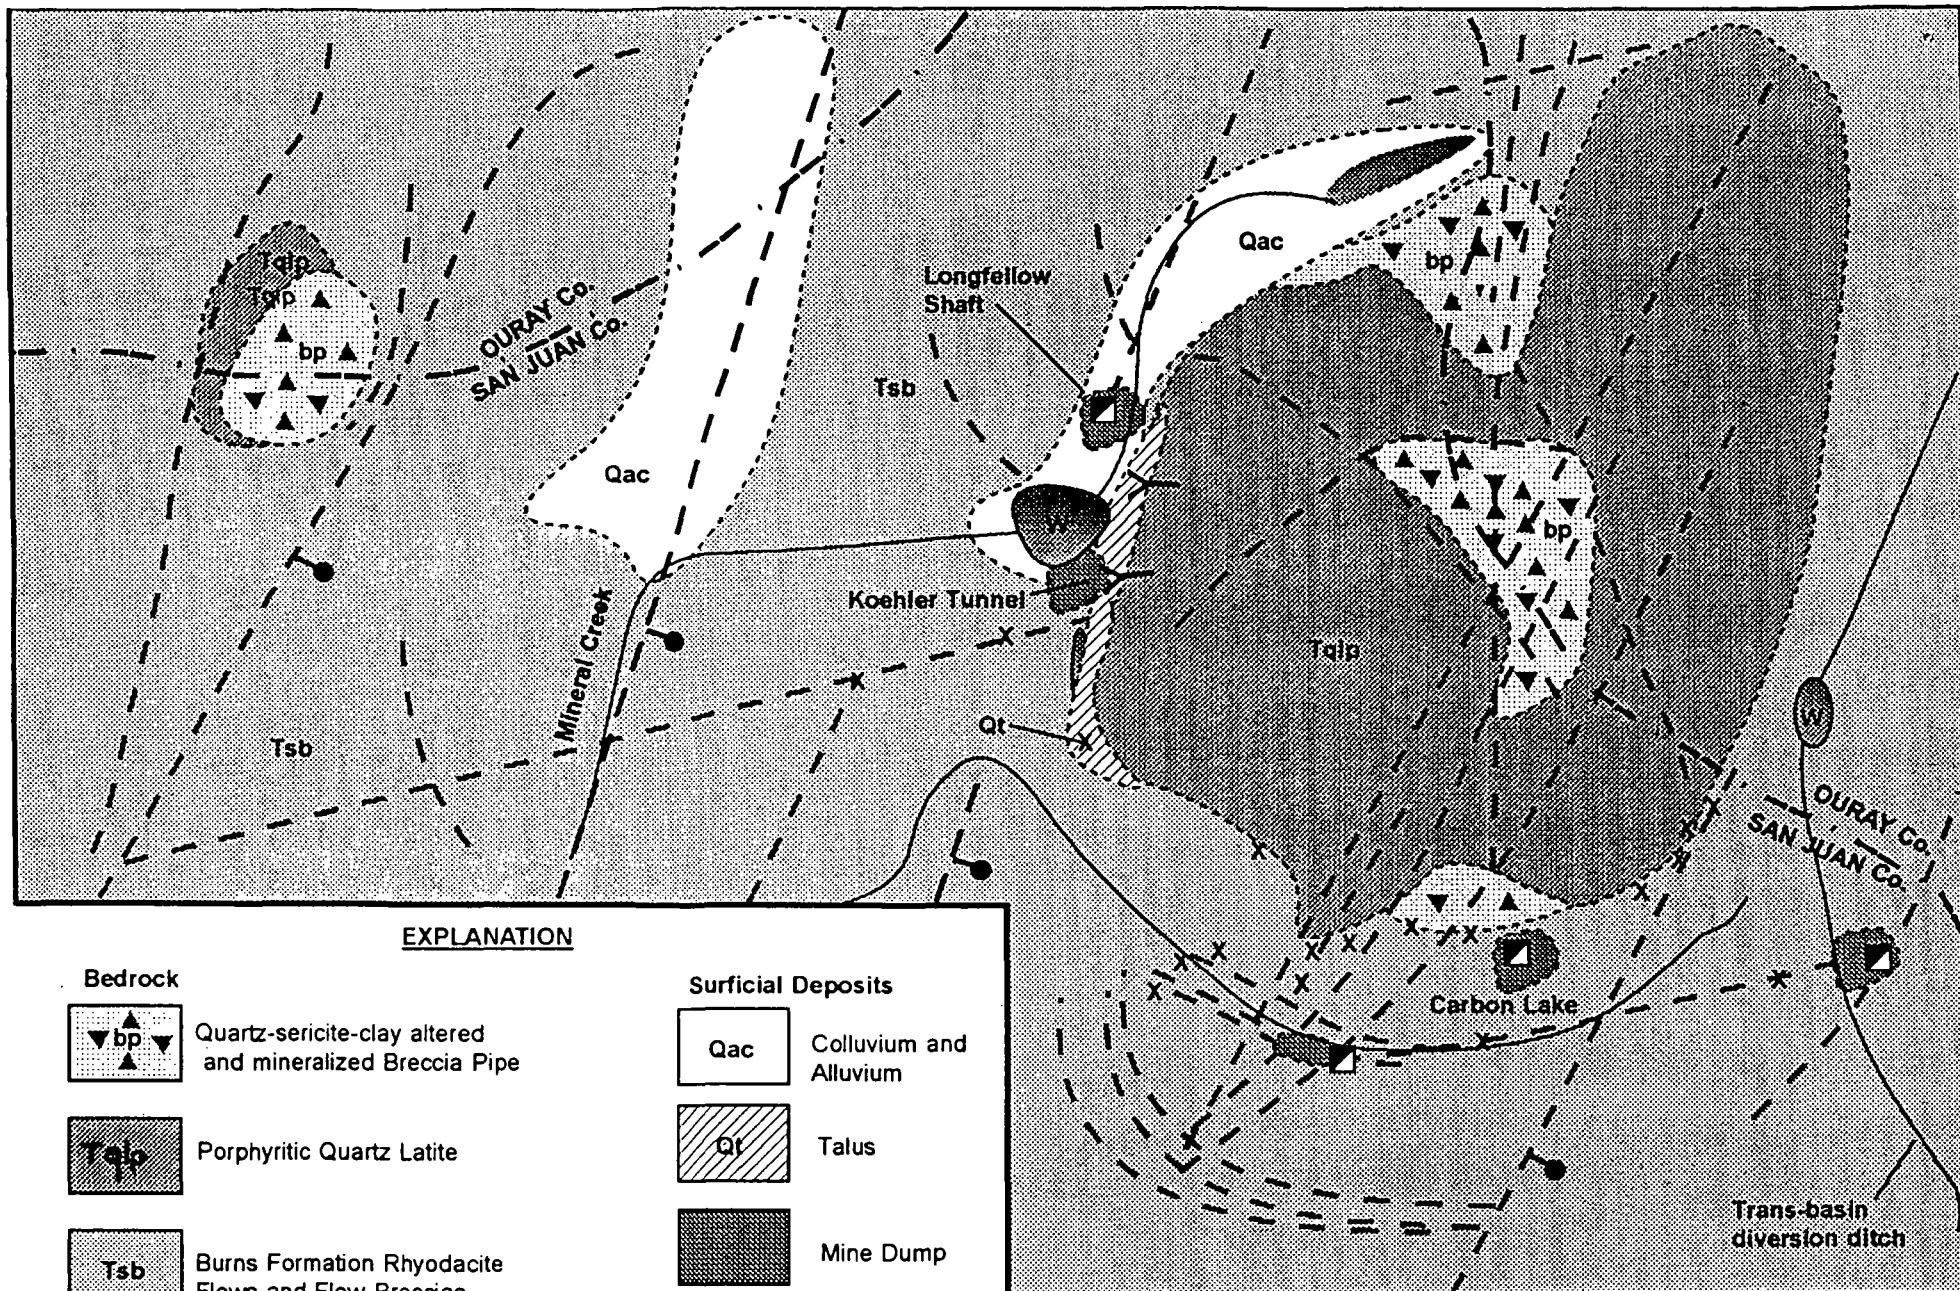
GEOLOGIC CROSS SECTION THROUGH LONGFELLOW-KOEHLER MINE SITE, RED MOUNTAIN PASS DISTRICT, COLORADO

The L-K site lies at the contact of a topographically prominent intrusive quartz-lattice-porphyry plug with ring-faulted caldera flows and flow breccia at the margin of the Silverton Caldera. The intrusive body forms a nearly vertical cliff on the east side of the site, into the base of which two adits have been driven south eastward. Within and along the margins of the intrusive plug are a system of altered, highly mineralized volcanic breccia pipes. These pipes and associated veins were developed by mining operations at the L-K site.

Structurally, the site lies across a complex system of ring-fracture faults related to subsidence of the caldera. The faults trend north 22° ^{east} through the site, and are associated with a belt of scattered, highly mineralized altered breccia pipes. These volcanic pipes are the hosts for rich silver sulphide ore deposits known in the Red Mountain Pass district. They probably occur here because the fractured, weakened zones at the margin of the caldera allowed upward venting and movement of epithermal ore bearing fluids and gasses. The faults are generally vertical to steeply east-dipping, with the sense of movement being downward toward the center of the caldera (east side of each fault). Numerous mineralized fault and fissure veins trend parallel to sub-parallel with the ring-fracture pattern through the L-K area, most showing similar sense of displacement.

A second mineralized fault set in the L-K area trends almost perpendicularly across the dominant northeast-southwest ring-fracture pattern. One of these fault veins strikes south 76° west extending from the margin of the intrusive porphyry across the southern part of the site 200 feet south of the Koehler Tunnel portal. This fault can be traced west at the surface all the way across and beyond Mineral Creek. It appears to be acting as a preferential groundwater flow path; on the north side the water in ponds and seeps adjacent to it are visibly red, have acid pH, and high metals. Just south of the fault trace, another pond and seep appear to have normal, non-acidic waters. It is possible that contaminated ^{ground} water from the L-K site is intercepted and conveyed over to Mineral Creek along this particular fault, and possibly others.
